Van's RV10 - Nose Undercarriage Mount Cracks

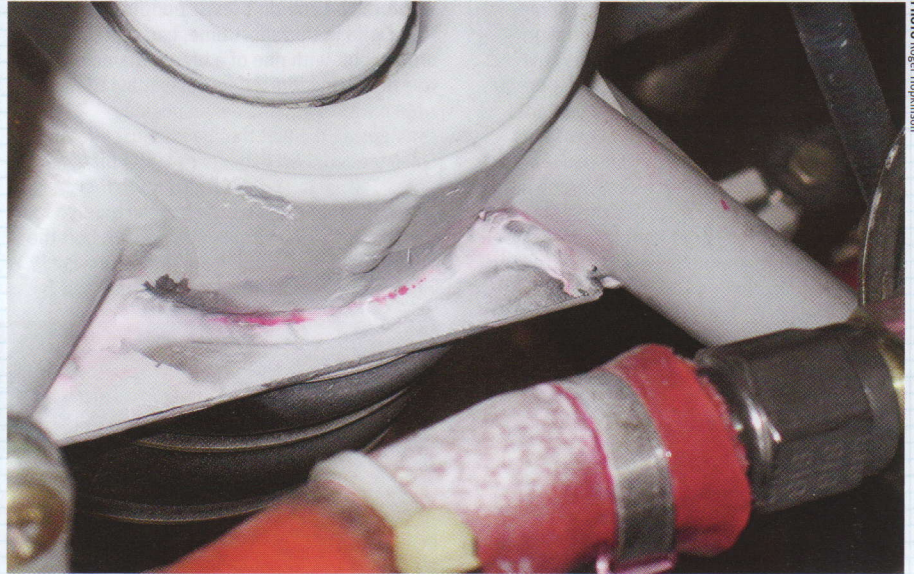
This would have been a difficult crack to spot if the access was easy. As it was, it was only seen because of a focussed inspection of the undercarriage support. Noticed that the crack is easier to see now that 'developer' has been sprayed over the area. The developer used here is essentially a fine chalk suspension, when the solvent evaporates an ultra fine layer of chalk remains which subsequently absorbs the previously applied dye penetrant left in the crack.

oil filter in place so it made sense to Roger, after filter removal, to put his inspector's hat on and carry out an annual inspection of the components that make up the top of the nose leg assembly. This was when he spotted the signs of cracking. Andy Draper, who acts as Roger's inspector as well as being an LAA Design Engineer here at HQ, could see that this cracking was the result of the repeated flexing of the flat plate as the elastomer ring bears

up against the landing/taxiing loads. Van's are working on a small design change here to prevent further cracking and Roger will be keeping an eye on this crack. LAA engineering has decided that this crack doesn't merit an immediate grounding as the primary load path is not affected. The repair itself will be quite a big job as the engine and engine mount frame will need to come out to accomplish the repairs and modifications.

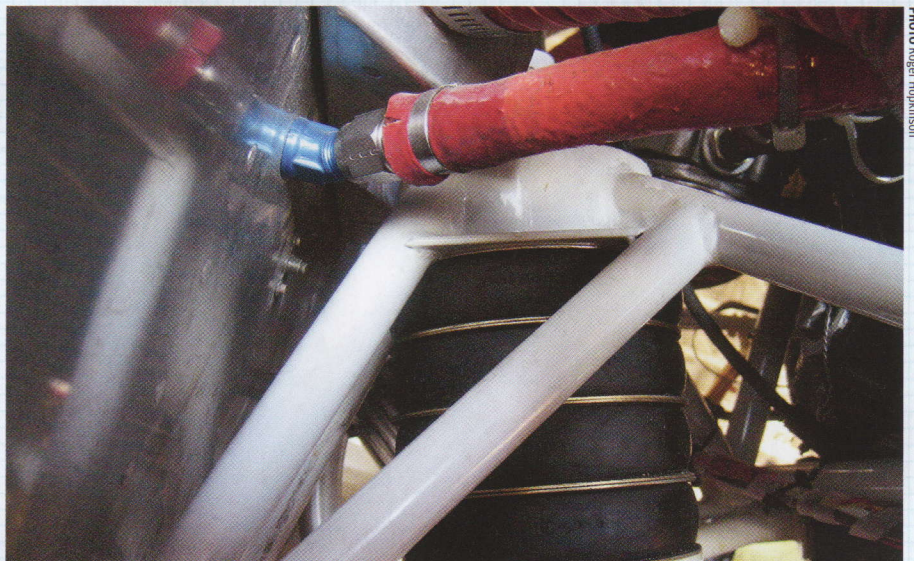
The RV10 employs rubber 'elastomer' blocks to provide energy absorption. It needs to be fairly firm as it has to take the weight of the (in our terms) huge Lycoming IO-540 six-cylinder engine. Van's engineers are coming up with a fix for the cracks found in Roger's machine which they think were caused by rocking within the elastomer separation plates.
