RANS

Airworthiness Directive: 135

Date: September 25, 2007

Subject: CAB-TANG Failure

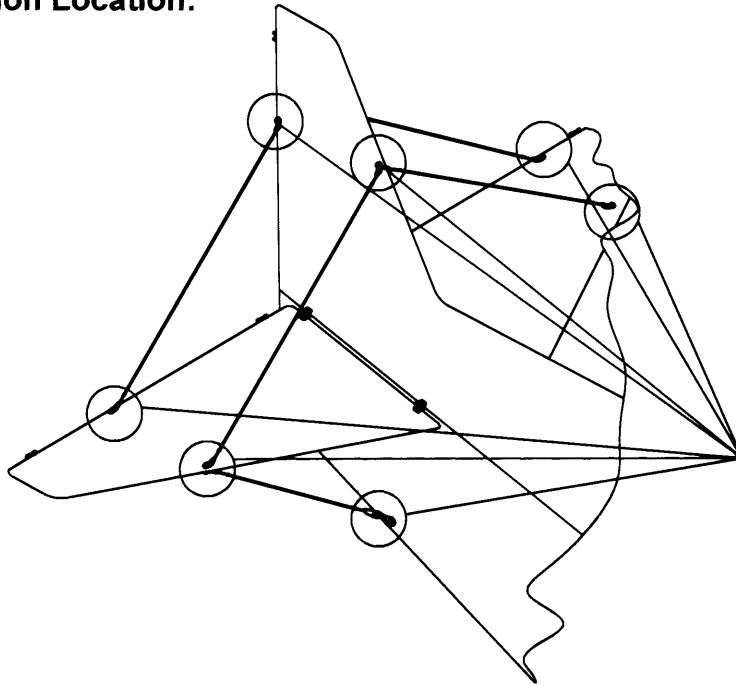
Inspection Location:

It has been brought to our attention that failures have occurred in the tangs at the ends of our tail brace cables. Some possible causes for this are:

1. Improper bending or re-bending of the tang during installation.
2. Improper tension of the cable resulting in vibration.
3. Pushing or pulling the cables during ground handling.

INSPECT ALL TAIL
CABLES AND TANGS

Inspect before next flight. If cracks or defects are found, remove the aircraft from service until it is possible to replace the cable assembly with latest revision.

Option 1 - Inspect all cables at 50 hour intervals and at condition inspection. Replace if cracks or defects are found.

Option 2 - Replace cable with latest revision and inspect at condition inspection. Contact RANS Parts Department for replacement parts.

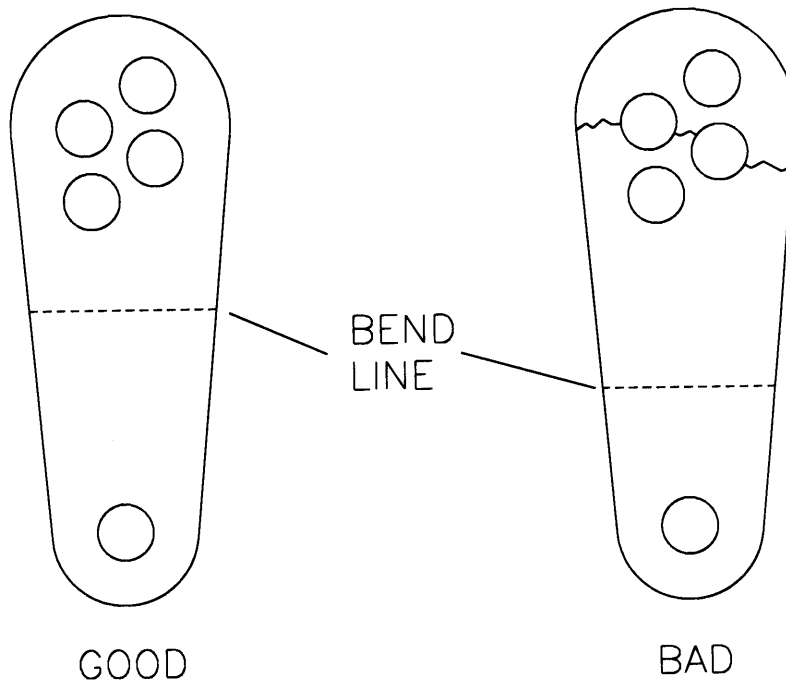
Inspection Procedure:

Remove bolts holding the CAB-TANG and inspect the tangs using a 10X magnifier.
