INFRA-08537

# External Assistance to Recreational Aviation Australia (RA-Aus) – Collision with water 22km NNW Gold Coast Airport, Qld Zenith Zodiac CH601 XL 7 March 2008

On 7 March 2008, a Zenith Zodiac CH601 XL aircraft, registered VH-ZRS, impacted the sea near Surfers Paradise, Qld. The pilot and the passenger were fatally injured. Recreational Aviation Australia (RA-Aus) commenced an investigation into the occurrence.

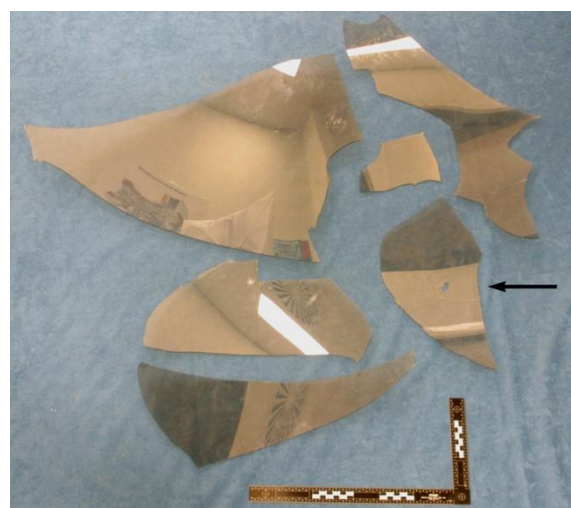
Six fragments of the aircraft canopy were submitted by RA-Aus for examination (Figure 2).

To investigate the possibility of a birdstrike, each canopy fragment was inspected for evidence of biological matter using ultraviolet light (UV). Many organic fluids contain molecules that are known to fluoresce from exposure to UV. The inspection did not reveal any evidence that might have otherwise provided an explanation for the canopy failure.

Comparison and examination of the canopy fragment fracture profiles found no correlation between the individual pieces, and it was generally evident that only a small proportion of the total canopy material had been recovered.

**Figure 2: Fragments of the aircraft canopy, as received: note the punctured canopy fragment (arrowed)**

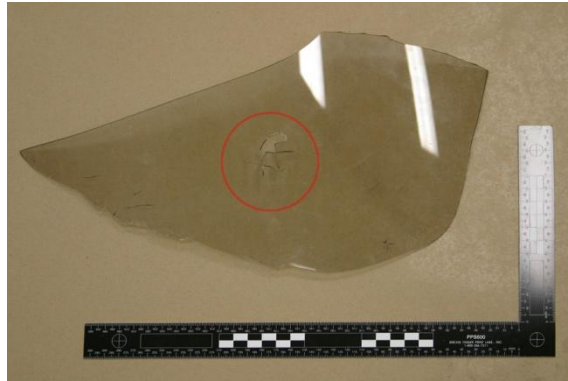
One of the canopy pieces showed a central puncture, approximately 20 - 25 mm in size (Figures 3 and 4). Under the stereo-microscope at high magnifications, a series of radiating river lines<sup>2</sup> were observed extending from the inner surface through to the outer surface. A radiating fracture in the manner observed suggested that the puncture had originated on the inner surface and propagated through to the outer surface. The fracture features also suggested that the canopy had been punctured from a single impact event of short duration.

**Figure 3:** The punctured canopy piece referenced in Figure 2

It was noted that while five of the fragments were 'undamaged', one of the canopy fragments had been punctured from the internal surface. Fracture surface morphology around this region suggested that the canopy had been punctured in an outward manner. Numerous related indentations were also located around the puncture on the internal surface and small cracks had initiated from some of those sites due to repeated impact loading. Given the confined spread of that damage, it is probable that the puncture had been produced by an object from within the cockpit while the canopy was still intact. A birdstrike to the aircraft was considered unlikely to have been a factor leading to canopy failure. A detailed ultraviolet light inspection of the canopy pieces did not reveal any evidence of biological matter. Had a bird been struck, it is expected that residual evidence from such an event would have been found.

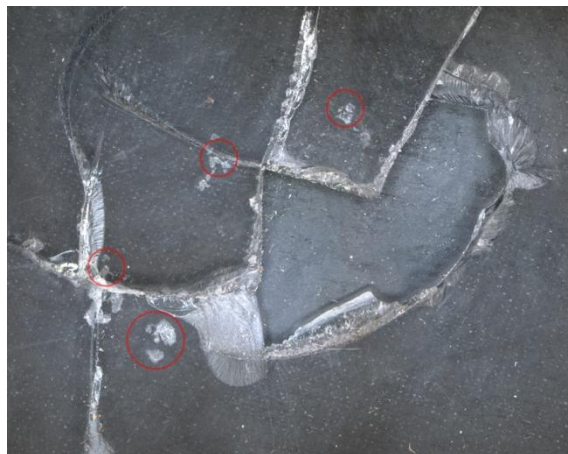
Numerous discrete indentations surrounding the puncture were also noted on the inner surface of the canopy fragment. Minor cracks were observed

**Figure 4:** Close-up of the canopy puncture showing several impact marks (circled)

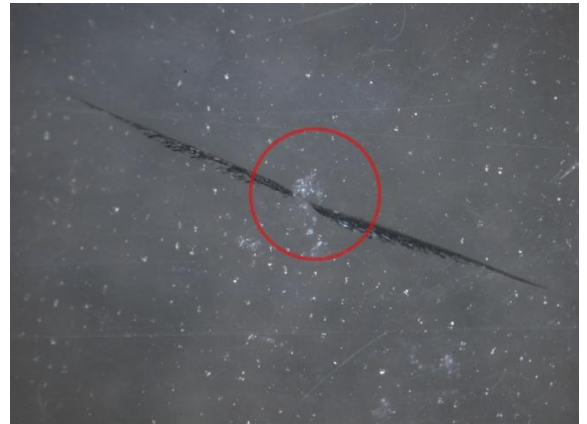
to have initiated from some of the indents (Figure 5).

**Figure 5:** Small crack from impact damage on the inner surface (circled)

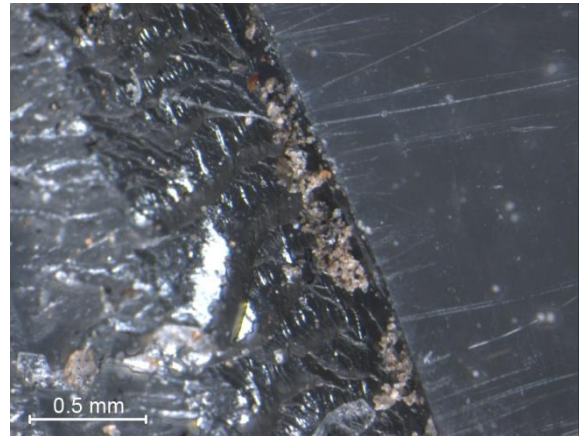
Small quantities of sand were noted adhering to the fracture surface associated with the punctured area (Figure 6). Given that all of the canopy fragments were found close to the beach, the presence of sandy deposits was not considered unusual.

**Figure 6:** Magnified view showing sand on the inner fracture surface
