## A Simple Reinforcement for the 601XL Rear Spar

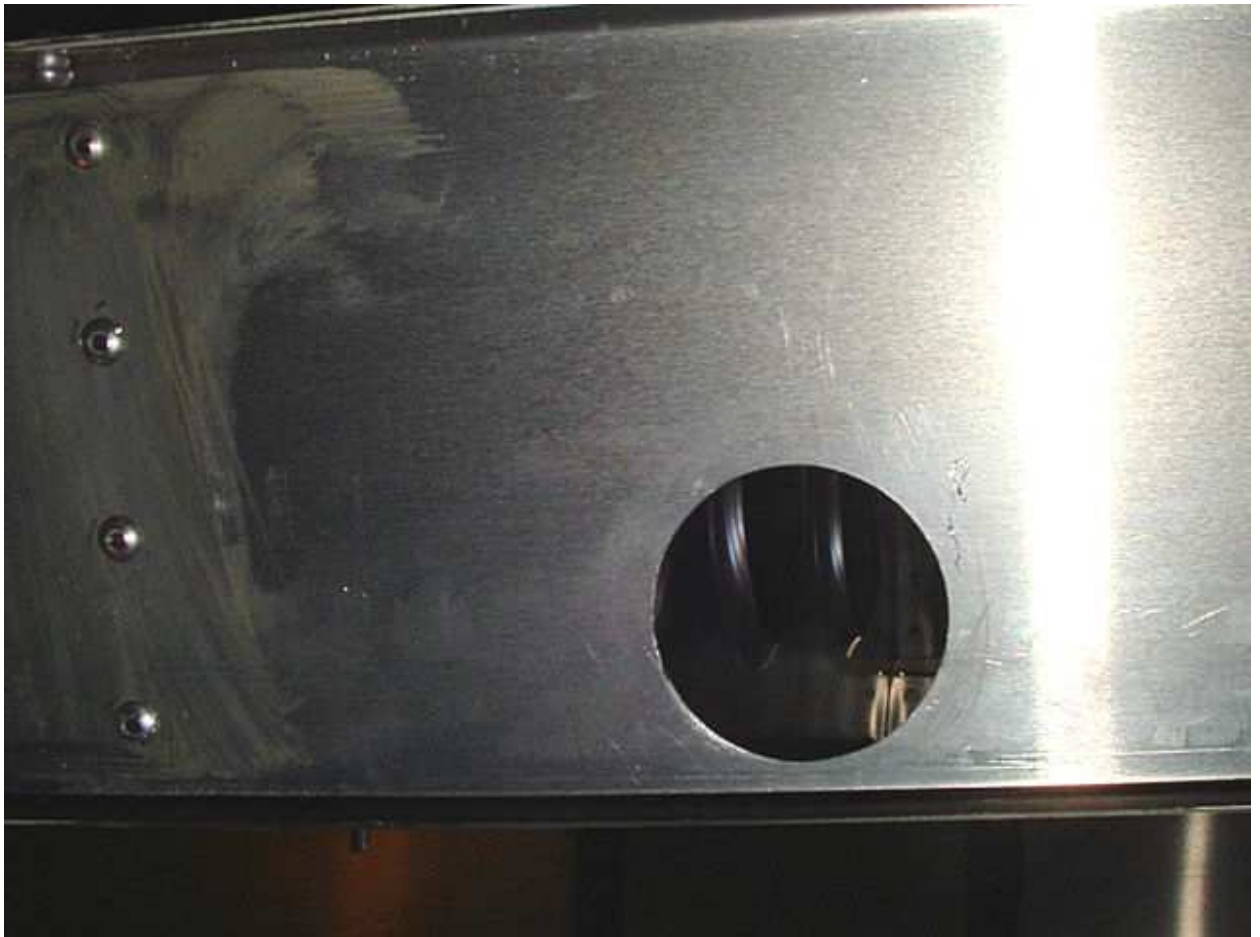
The only thing I found was that the clearance hole for the aileron pushrod is rather large and is located rather close to the rear spar lower flange. It would be easy during construction to make this hole closer to, or even touch the flange. Since the top and bottom of the spar carry the large part of the wing bending load, this *could* weaken the spar.

It would also be easy to nick the edge of the hole when smoothing it out. This could create what is called a *stress riser* and over time, metal fatigue could cause a small crack to form and that could grow into the flange and be a problem. That could also be caused by the pushrod rubbing against the hole edge, especially if you have the flex ailerons (as opposed to hinged).

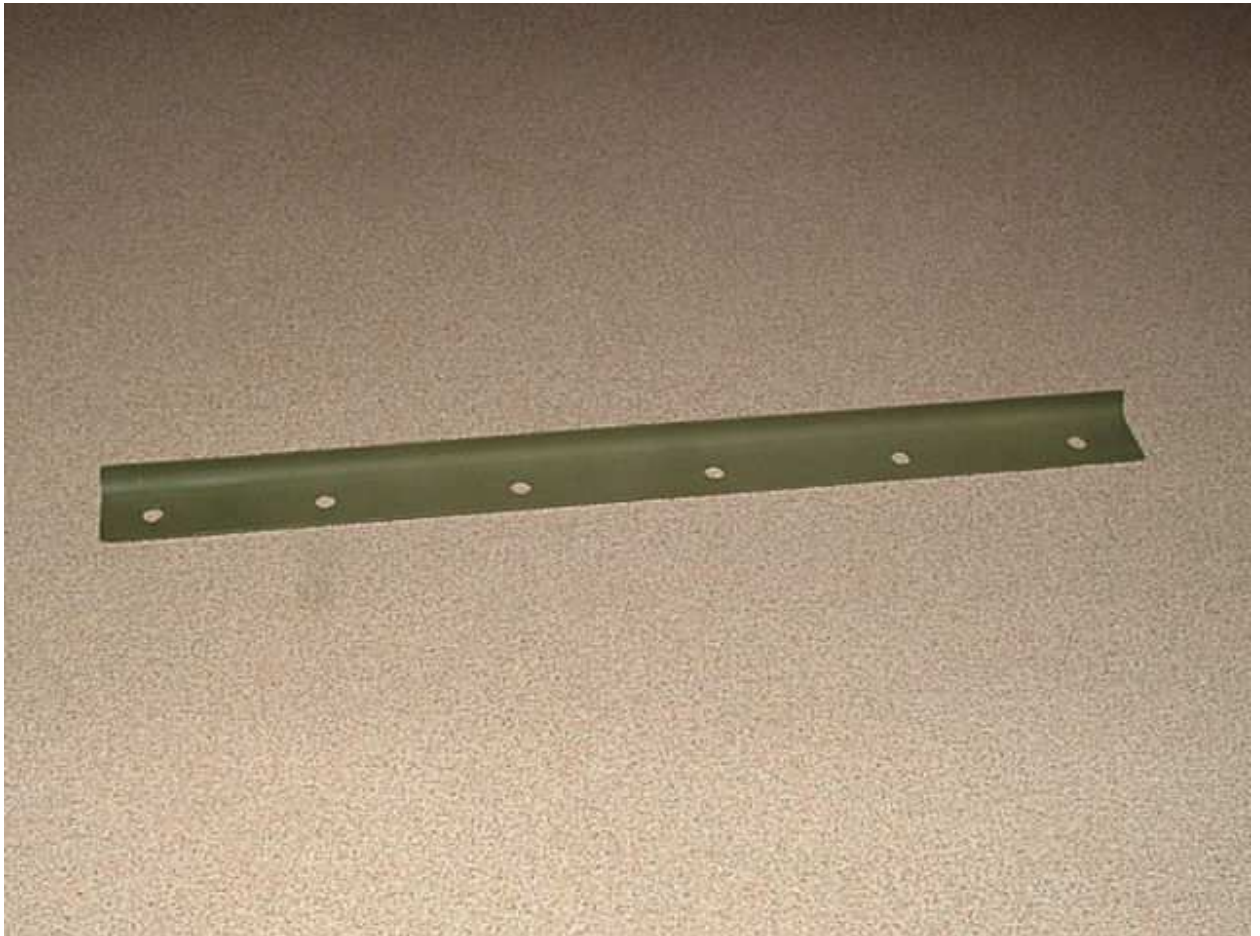
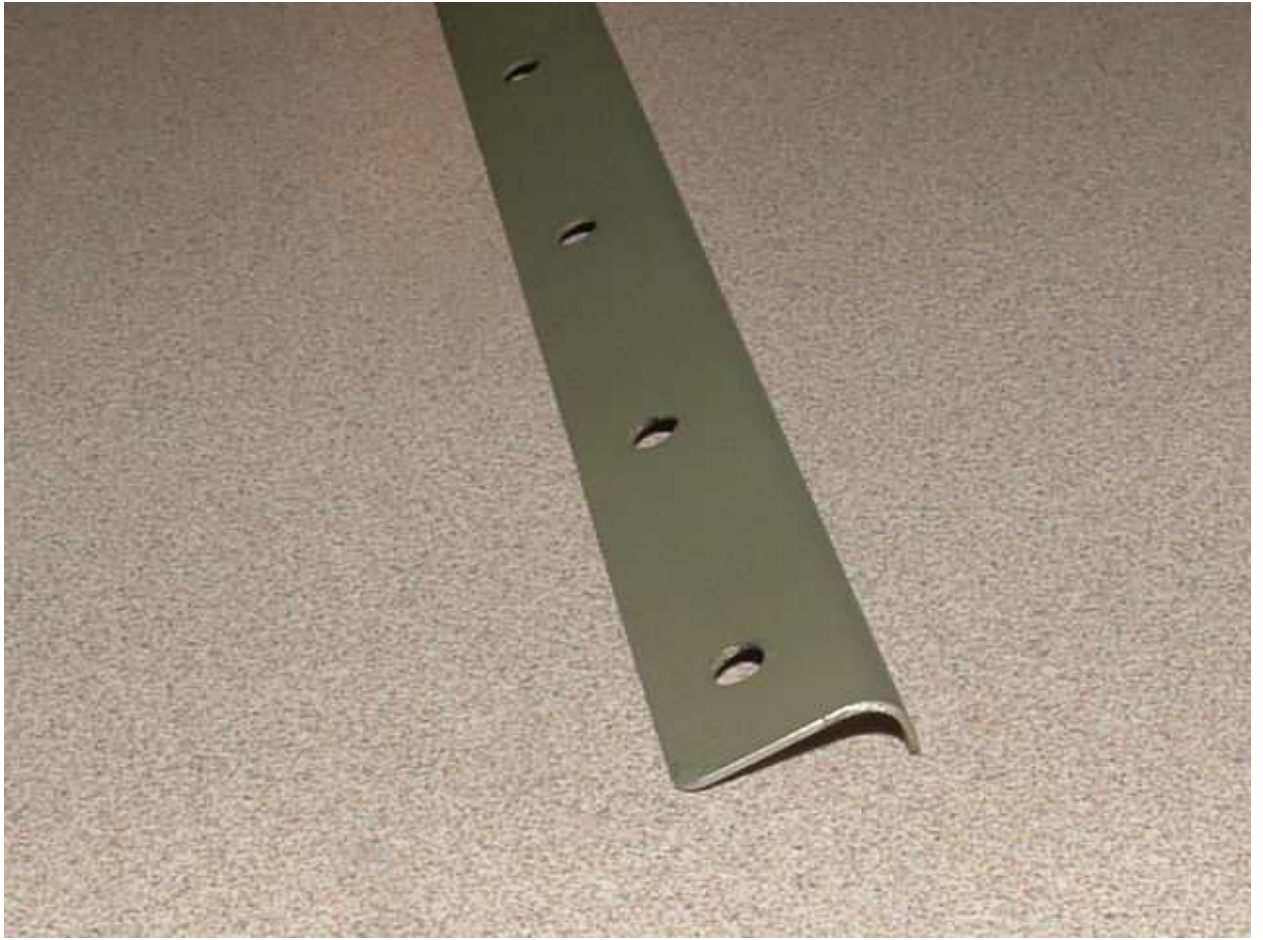
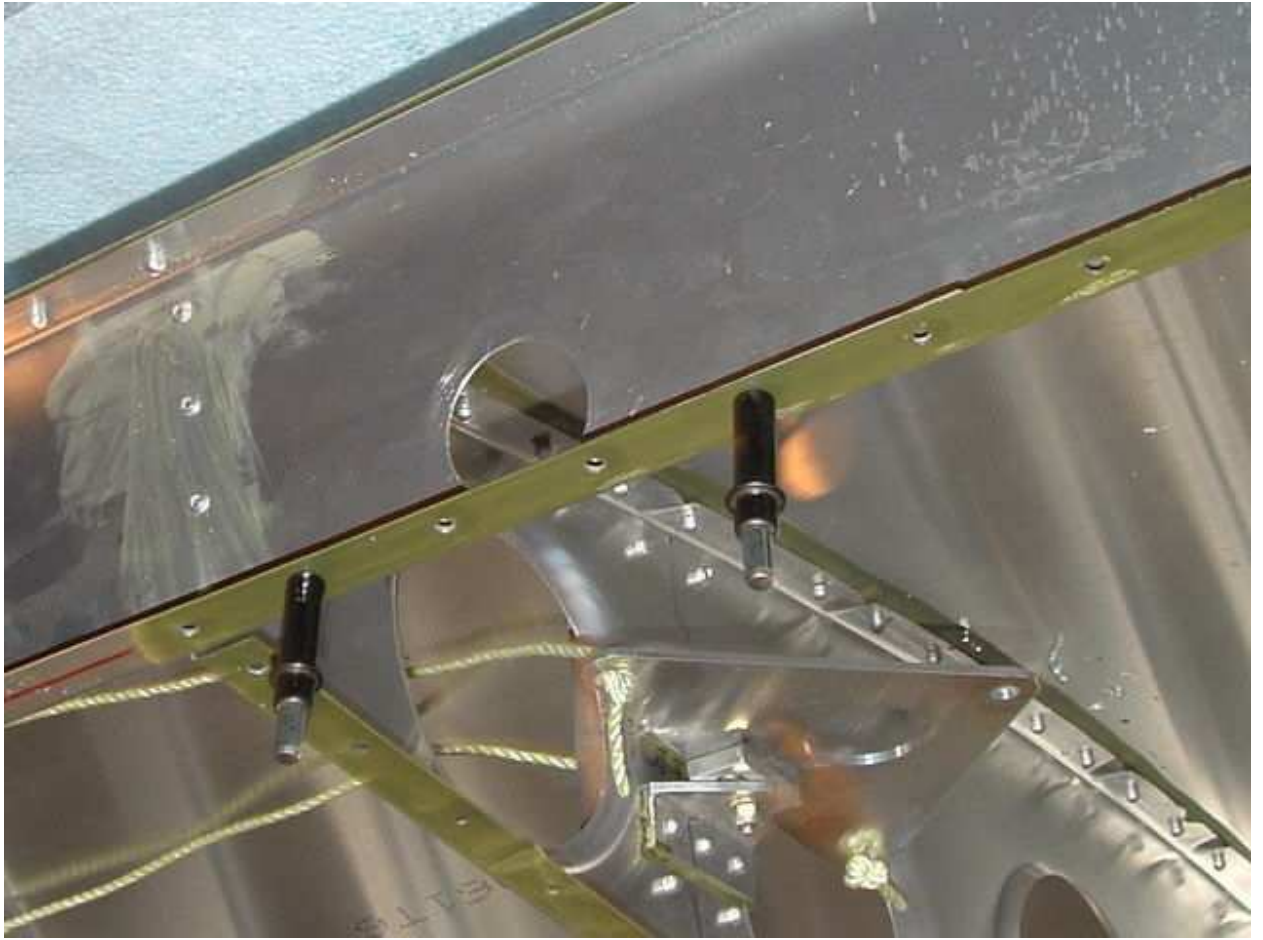
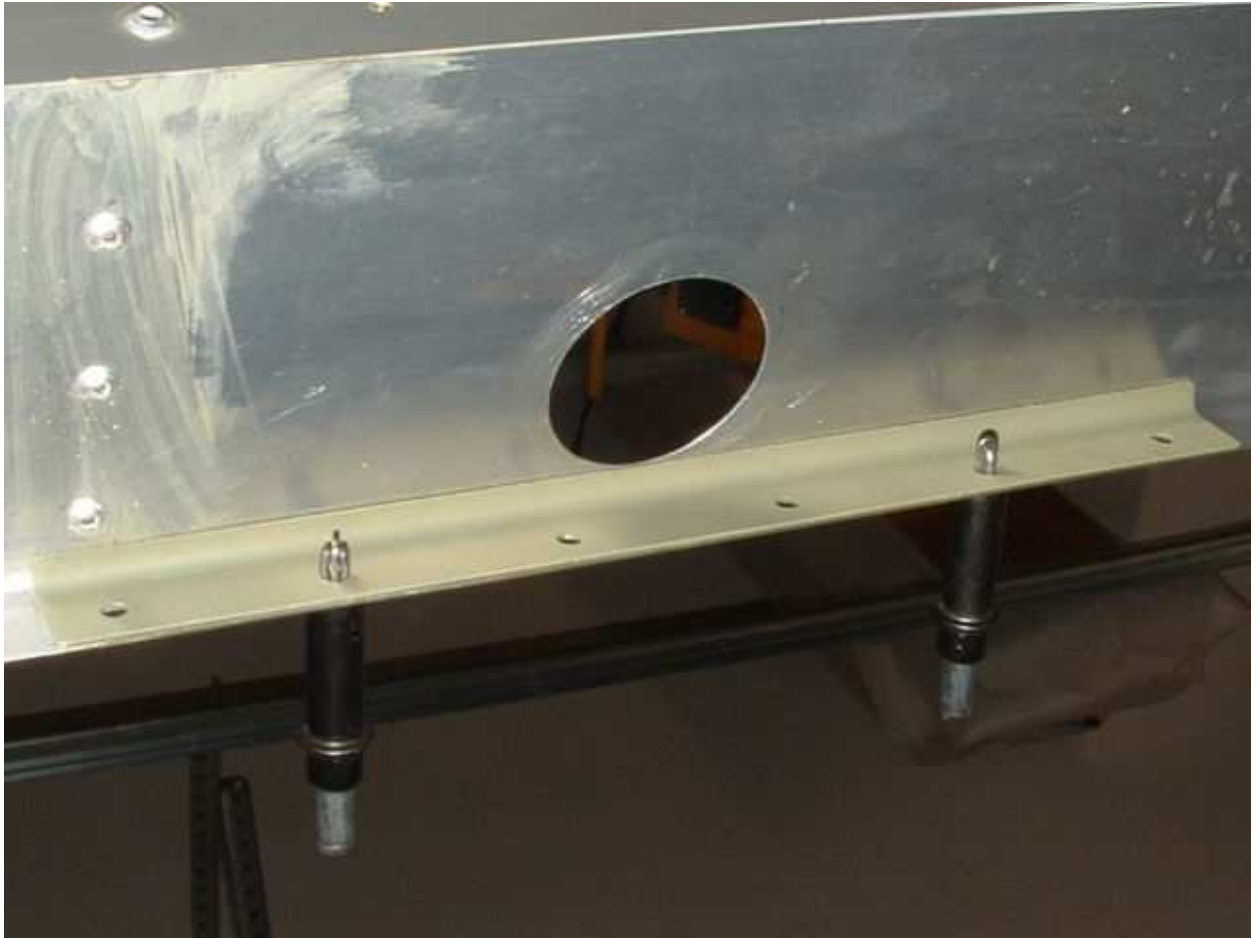
This small doubler strap reinforces the flange in the *hypothetically* weaker section of the spar, and thereby helps transfer wing bending loads across the hole. It has many good characteristics (below)

I cut a piece of .025 standard angle to a length will cover the three A5 rivet holes in the bottom flange on both sides of the aileron pushrod hole. I bent the piece to match the angle of the spar flange, then trimmed it to fit flush with the flange and also to clear the exit hole. Finally, I match drilled it to the spar, then deburred and primed.
