Europa Aircraft (2004) Ltd
7 Dove Way
Kirkby Mills Industrial Estate
Kirkbymoorside
York
England
YO62 6QR

Issue 1 June 10th 2009

Standard Wing Skin Repair Scheme

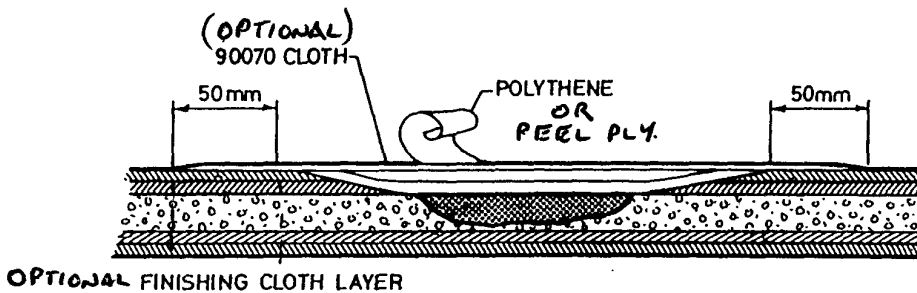
Fig 1F

CLOTH PATCH

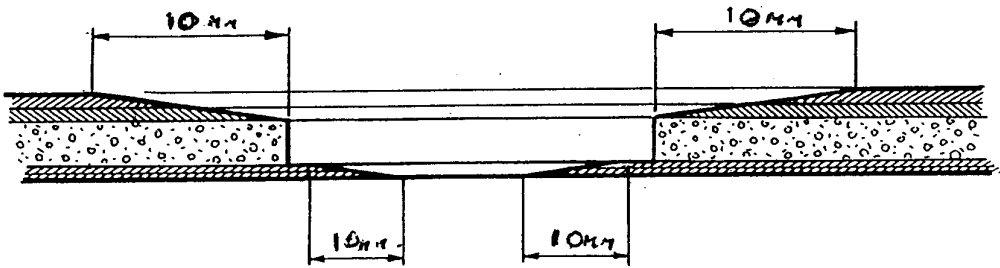
Fig 2A

TYPICAL DAMAGE

INNER SKIN
