## PFA AIRWORTHINESS INFORMATION

### EUROPA CLASSIC AND EUROPA XS TAILPLANE FLUTTER AVOIDANCE AND INTEGRITY OF TAILPLANE ATTACHMENT

**Applicability:** All Europa Classic and Europa XS aircraft.

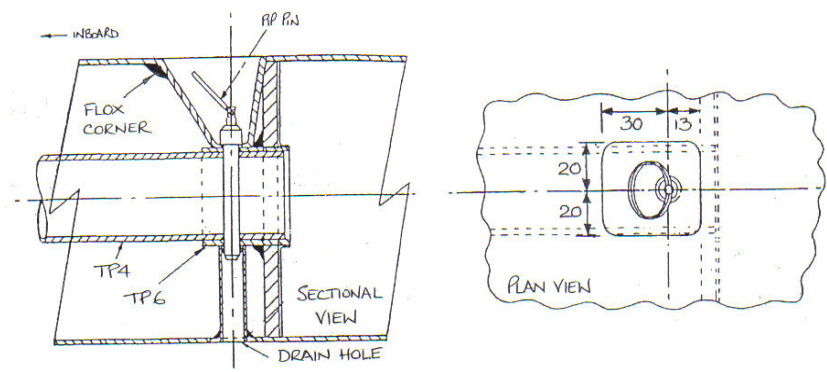
5. Check that the tailplane pip-pin recess complies with the description in the Europa Build Manual (see diagram). Build instructions were changed in March 1994 from a recess design similar to that shown below but had slightly smaller dimensions. This recess type is also acceptable. An important feature of the recess is that its base and inboard side wall provides a secondary tailplane retention function in the event of dis-bonding of the TP6 bush. Reports from inspectors reveal that there are many cases of aircraft being found to have tailplane pip-pin recesses that differ from the build manual in both shape and dimension. Inspectors may only accept variations in recess design if the modified version includes all of the following essential features:

- a) The sides and base of the recess is totally covered by a minimum of two plies of bi-directional glasscloth.
  - b) The base of the recess in contact with the TP06 outboard bush has an area of at least 170mm<sup>2</sup>.

- c) The connection between the recess side walls and the tailplane skin has a perimeter of at least 125mm minimum.
  - d) The joint between the recess side walls and the tailplane skin is made using a 'flox corner'.

If the pip-pin recesses do not satisfy the above criteria, the aircraft must not be flown until modified in accordance with part 7 below.

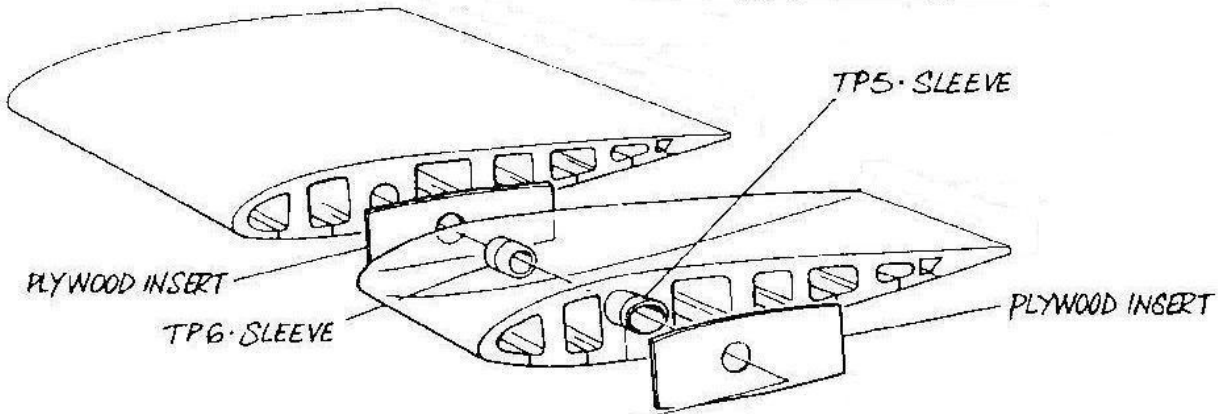
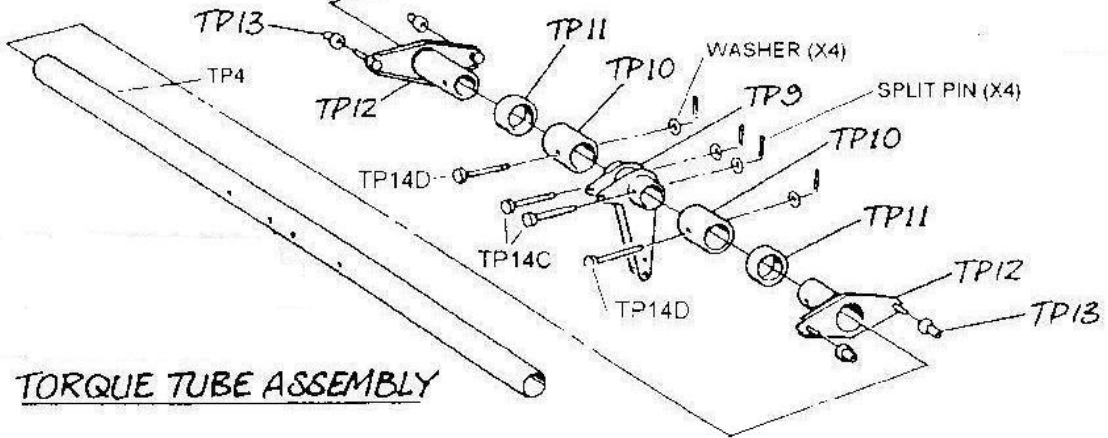
# TAILPLANE COMPONENTS

1. Check for relative movement between the tailplane mass balance arm and the tailplane torque tube TP04. PFA's Europa Safety Bulletin PFA 247/FSB-002 dated 18.04.00 refers. Play of this sort is most likely due to worn holes for the TP14 interference fit pins in the TP09 torque tube drive horn assembly or at the arm attachment to the TP09 horn. Due to the vital role of the mass balance arm in preventing tailplane flutter, the play between the mass balance arm and either tailplane half must not exceed 1/2" measured at the tailplane trailing edge. This must be measured by having an assistant hold the P1 control column full back so that the mass balance arm is pressed against the up stop, and measuring the free play at each tailplane trailing edge under moderate up/down hand pressure. In cases of free play exceeding 1/2", Europa mod 62 provides a repair scheme for eliminating play in mass balance arm attachments. See diagram.
