**EUROPA CLUB  
AIRCRAFT MODIFICATIONS**

**OUTRIGGER PIVOT BEARING  
(MOD NUMBER 10661)  
(Version 2 -May 2007)**

## **OUTRIGGER PIVOT BEARING INSTALLATION**

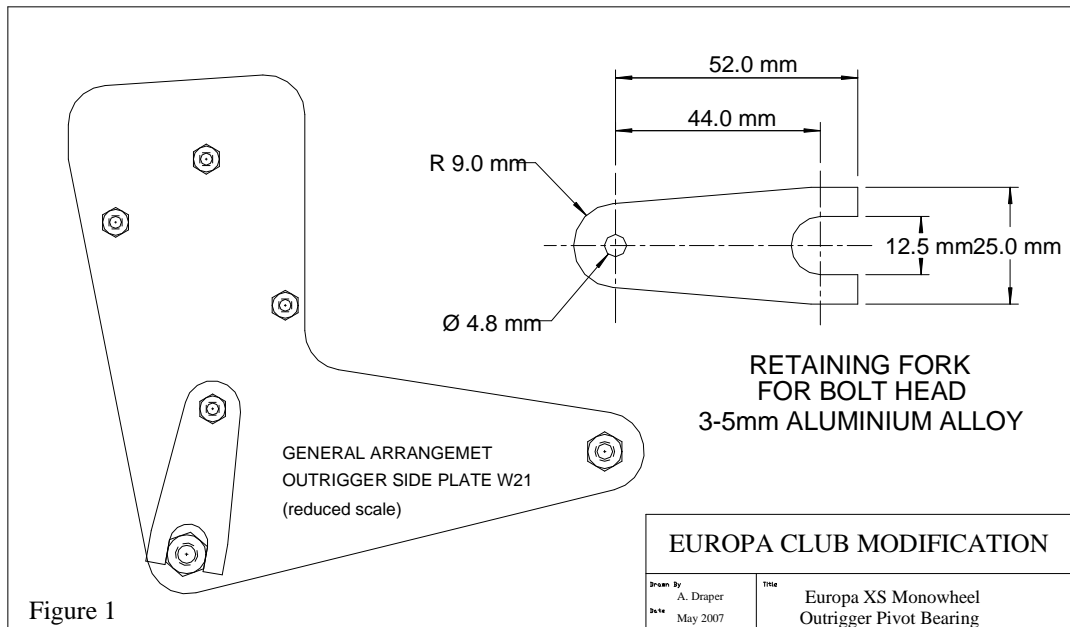
Firstly the pivot bolt and the outrigger are both free to rotate independently leading to wear on both the head of the outrigger (OR1) and the pivot support plates (W21). The factory have supplied inserts to reduce the wear on the W21's but this is only a slight improvement as any lubrication is soon displaced allowing wear to continue at a slower rate. It also does not prevent wear within the OR1.

Secondly the pivot bolt tightening is critical. If it is slightly too tight it causes the outrigger to drag on the W21's (leading to gear lowering problems). If it is too loose the leg is sloppy (accelerating the wear described above).

Make up the retaining fork as shown in Figure 1 using at least 3mm sheet aluminium (3/16" / 5mm is ideal). The slot should be initially made slightly undersize and the bolt head used to judge how much material should be removed to create a sliding fit. If thick enough plate is not readily available I have a limited supply.
