KIS Nose-Wheel Assembly

Taken from KIS4 – N819PR (4/28/2013)

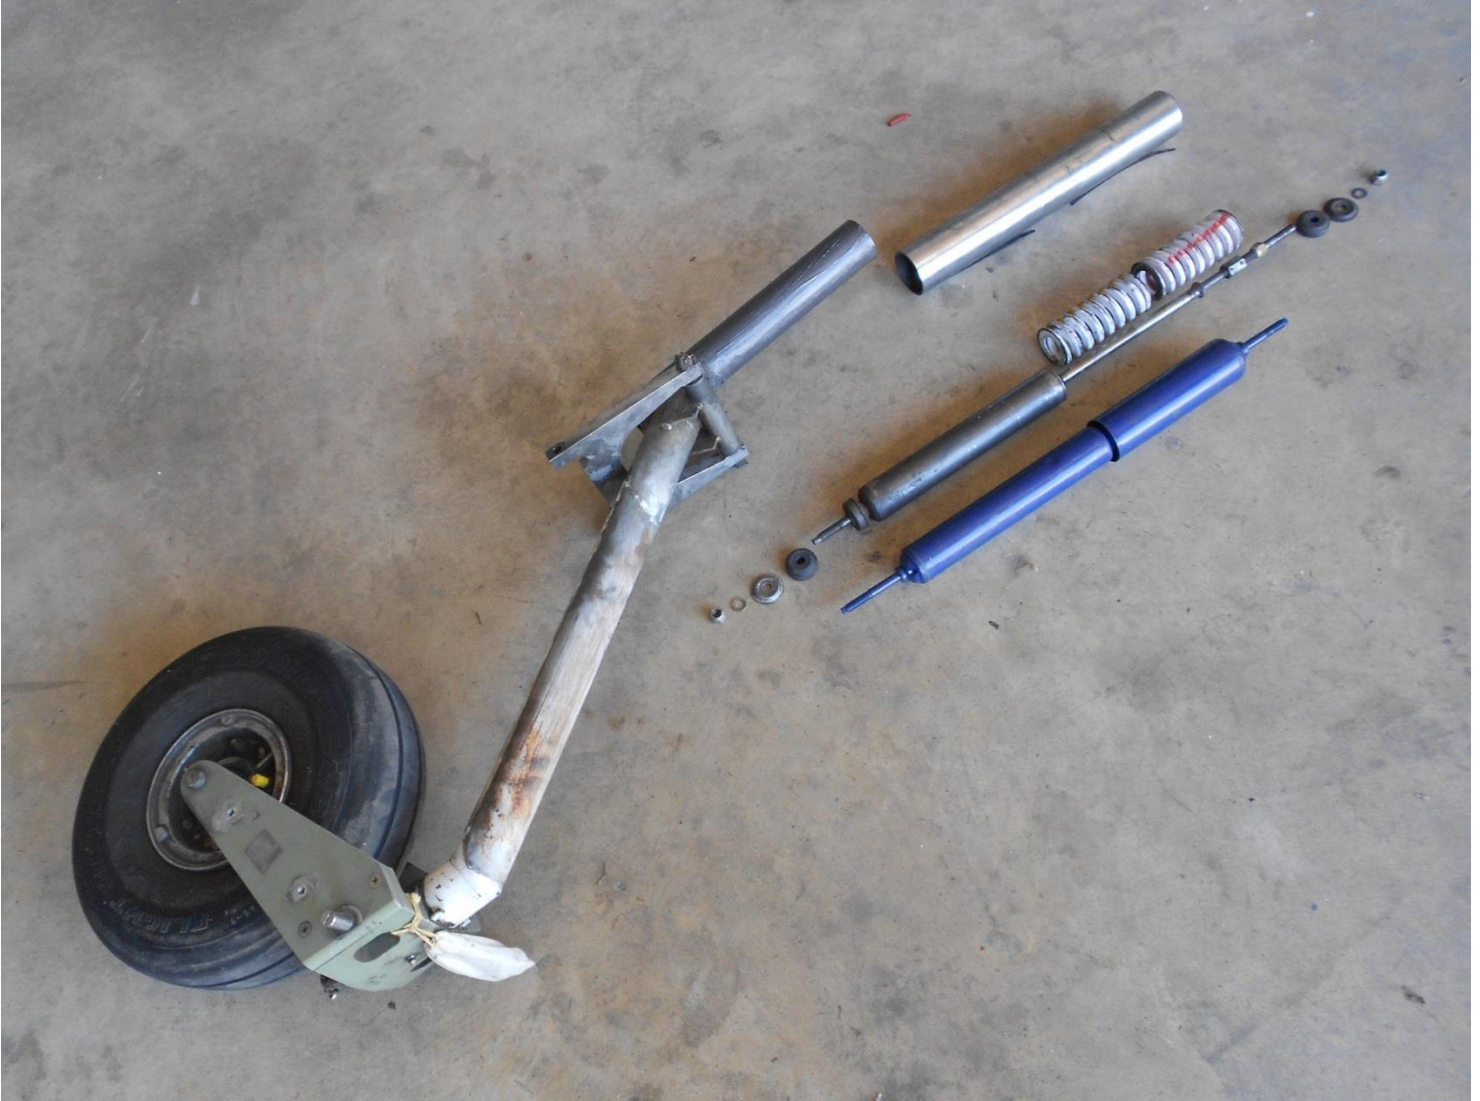
Disassembled Nose Wheel Assembly

How the parts go together inside the nose-wheel assembly. The bright "chrome" part is the top of the assembly.

The top of the old shock absorber has the "dust cover" cut off and a 3/8" dia. lengthening adaptor threaded rod is affixed to it. The shock absorber measures a total of 25" long from the top of the lengthening adaptor threaded rod to the bottom of the shock absorber threaded rod. Two 4-1/2" steel springs are inserted as spacers where the dust cover would have been. NOTE: The blue new replacement shock absorber (Monroe-Matic Plus 31069) does NOT have its dust cover removed in the picture.

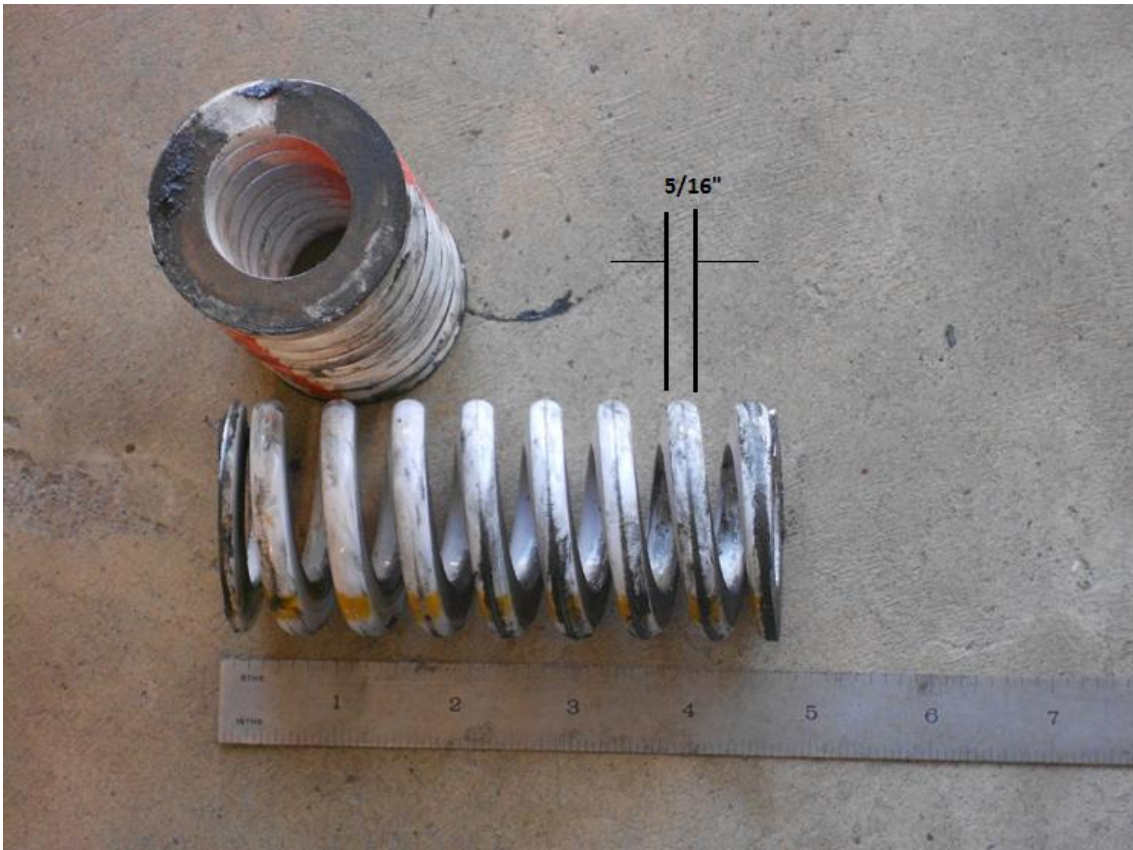
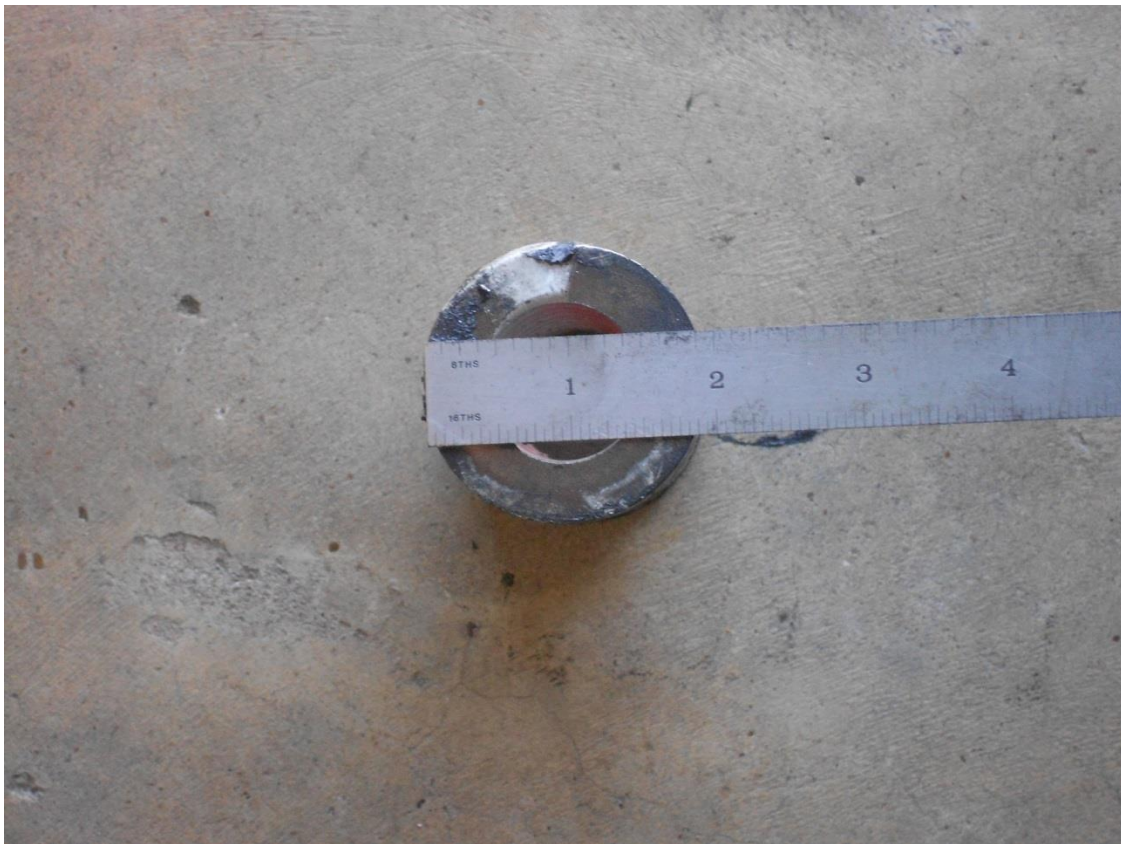
Steel Springs Measurements

Each steel spring is 4- $\frac{1}{2}$ " long and 1- $\frac{15}{16}$ " in diameter made of $\frac{5}{16}$ " thick steel.

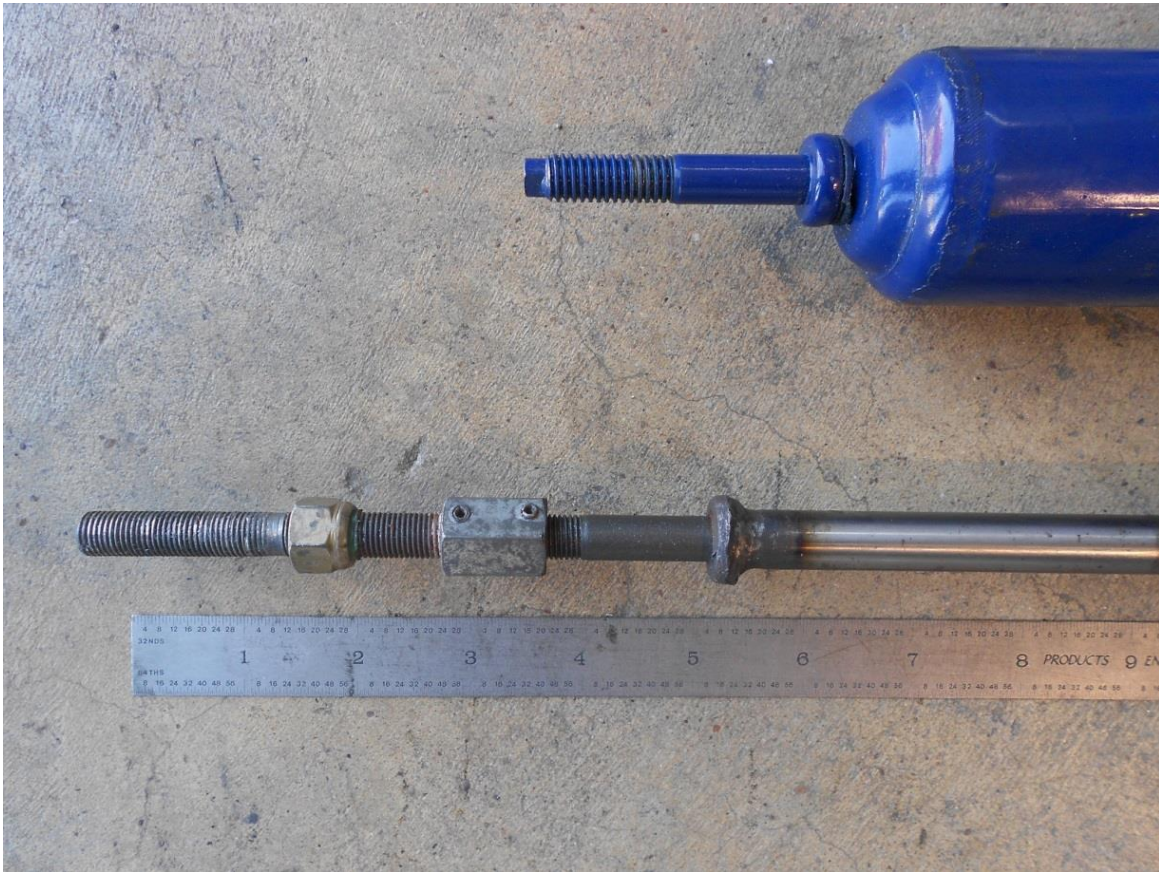
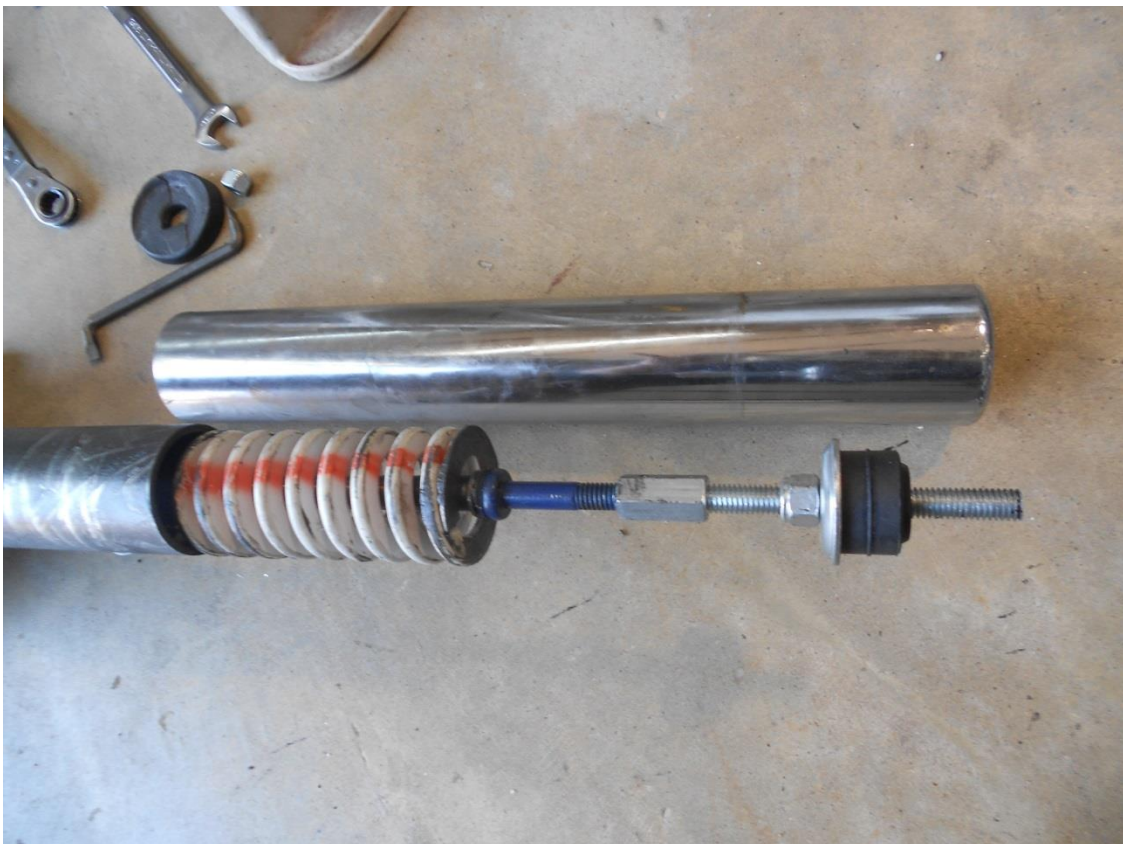
Top of the Shock Absorber (Monroe-Matic Plus 31069)

NOTE: The blue replacement shock absorber does NOT have the dust cover removed in the pictures.

The 3/8" dia. lengthening adaptor threaded rod is shown in detail in the previous photos. The nut provides a stop to help prevent it being over tightened during installation. A rubber grommet is placed there to prevent a metal to metal connection which winds up inside the assembly.

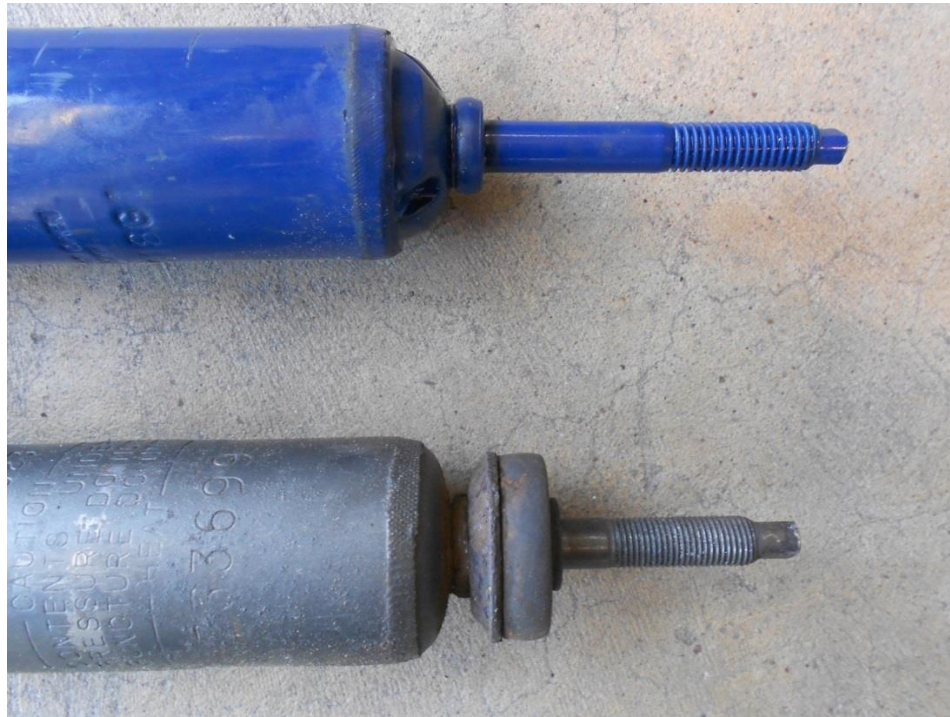
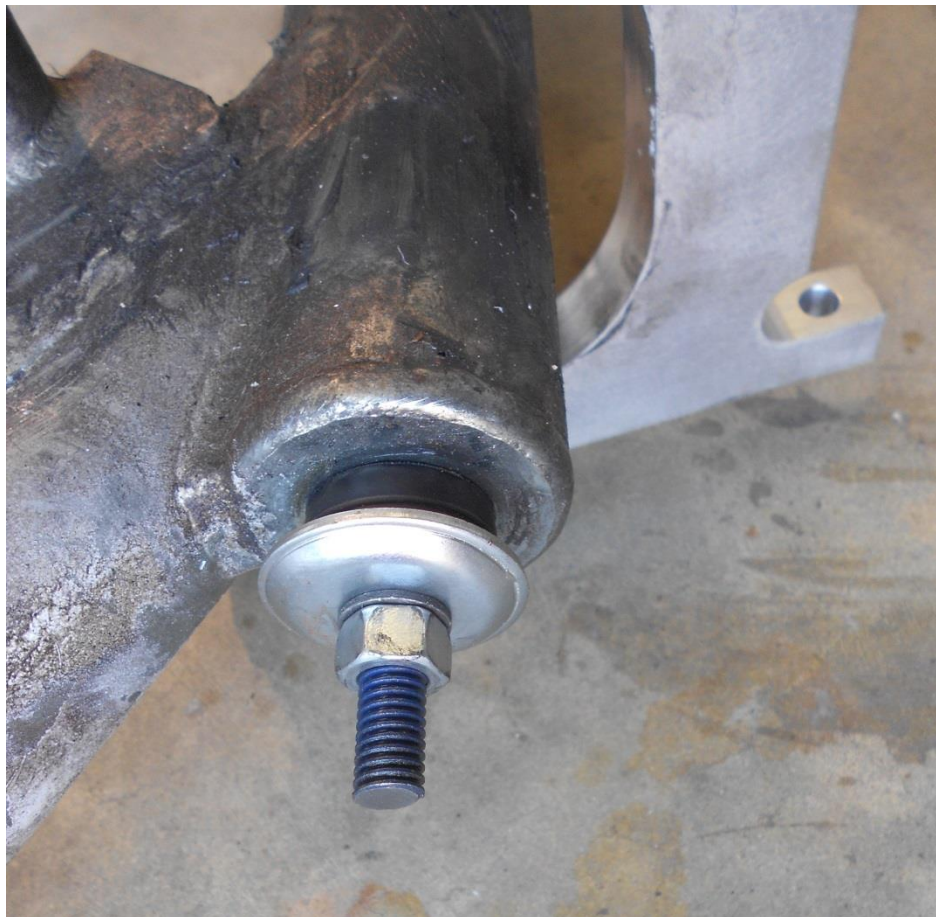
Bottom of the Shock Absorber (Monroe-Matic Plus 31069)

There is a rubber grommet on the bottom of the shock absorber inside the assembly and on the bottom of the entire assembly as seen in the above photos.

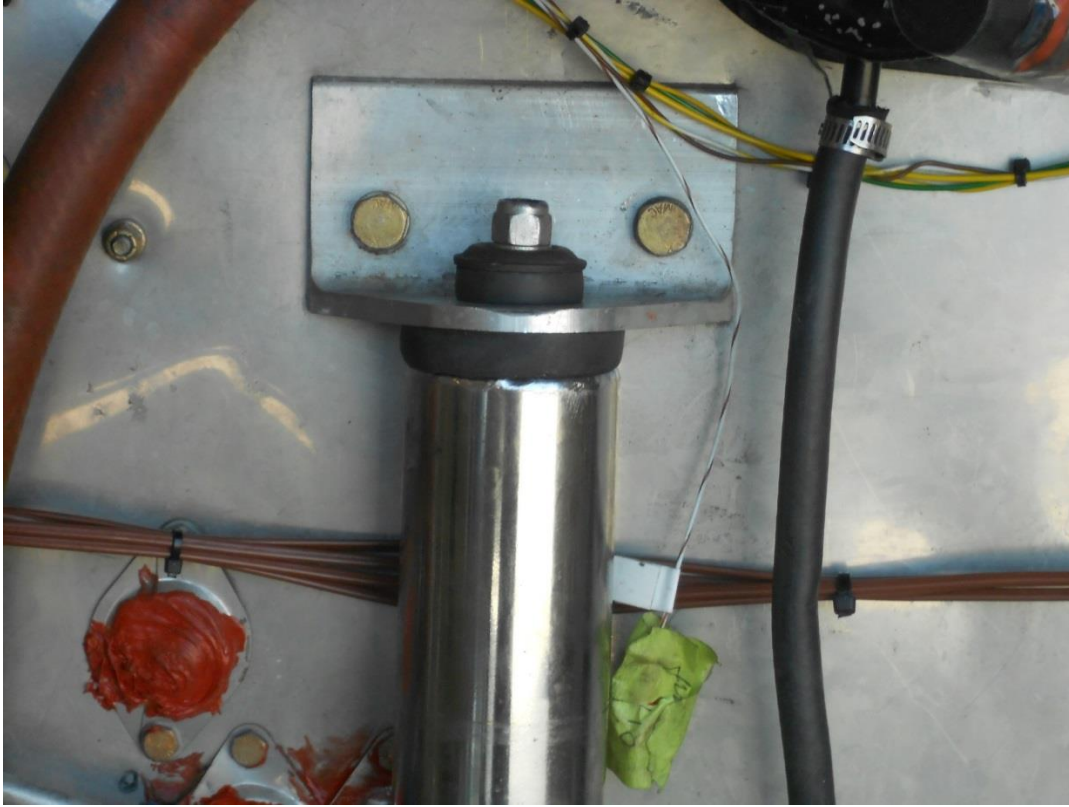
Shock Absorber inside the assembly.

There is a thick piece of rubber or polyurethane between the outside top of the assembly and the firewall mounting bracket, as seen in the above photo, to help diminish forward/rear torque forces during landings. There is a rubber grommet on top of the firewall mounting bracket. I installed a hard plastic bushing inside the aluminum mounting bracket to prevent the lengthening adaptor threaded rod from cutting in to the bracket during landings.

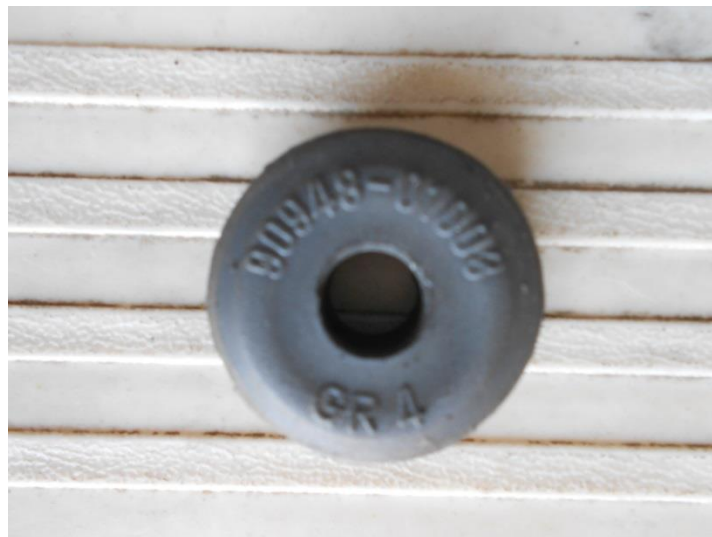
The rubber grommets supplied with the replacement shock absorber were too thick for my particular installation. I would up using a thinner ones (90948-01003 GR4) inside the assembly as seen in the above photo.
