Landing gear frame cracks

Europa XS monowheel - N262WF.

Hobbs hours = 1024

No. of landings = 1490

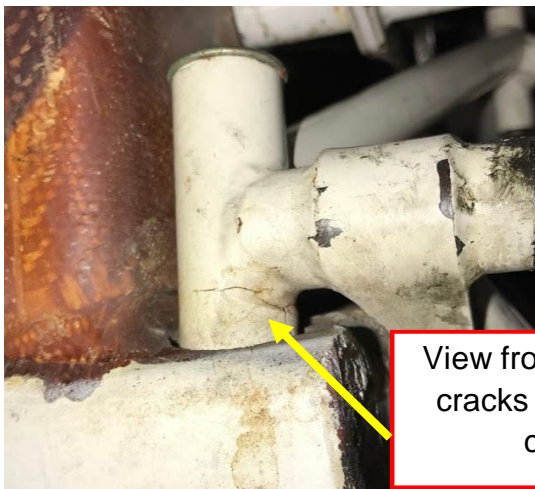
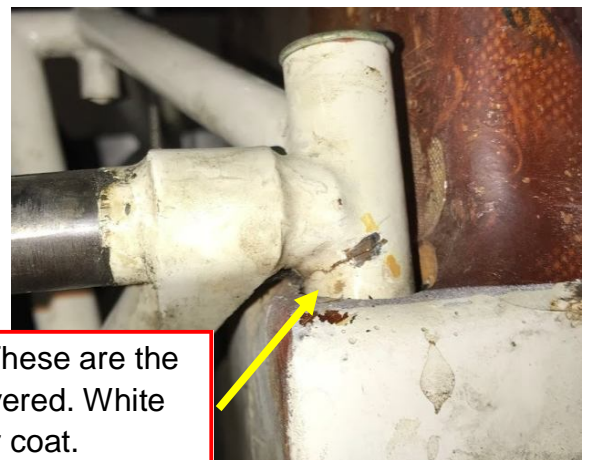
View from underneath. These are the cracks when first discovered. White coating is powder coat.

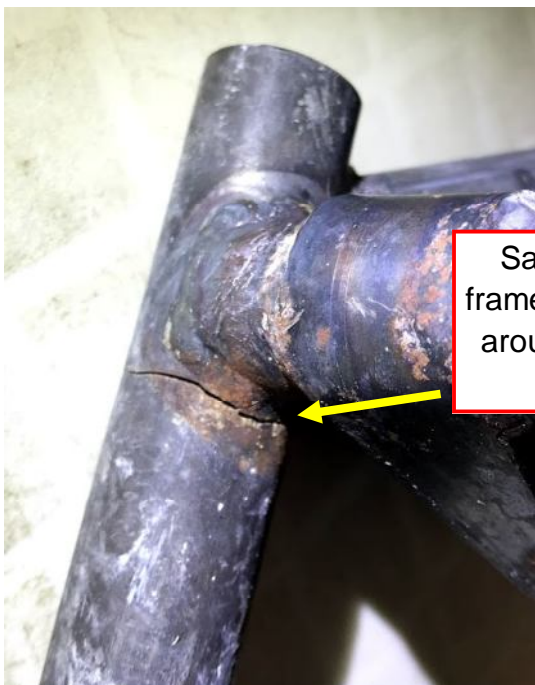
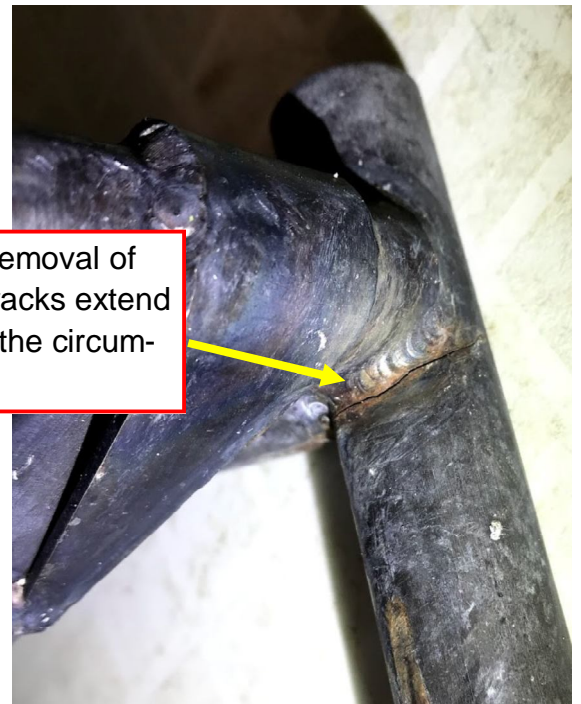
Same cracks after removal of frame from a/c. The cracks extend around 40 to 50% of the circumference.
