INFRA-08537

# External Assistance to Recreational Aviation Australia (RA-Aus) – Collision with water 22km NNW Gold Coast Airport, Qld Zenith Zodiac CH601 XL 7 March 2008

On 7 March 2008, a Zenith Zodiac CH601 XL aircraft, registered VH-ZRS, impacted the sea near Surfers Paradise, Qld. The pilot and the passenger were fatally injured. Recreational Aviation Australia (RA-Aus) commenced an investigation into the occurrence.

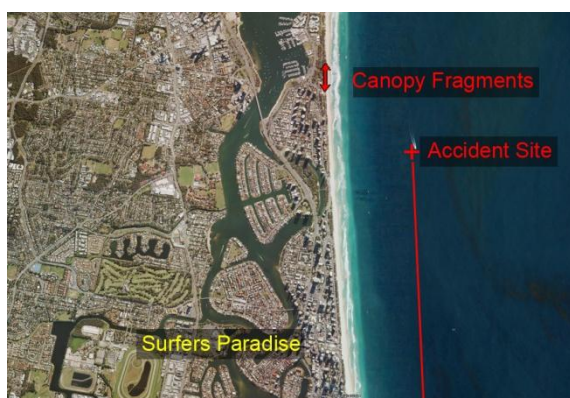
During the subsequent search and rescue effort, several fragments of canopy from the aircraft were found on land near the Southport Surf Club. One of the fragments was found on the roof of the surf club while the others were located along the beach. Figure 1 details the accident site and flight path of the aircraft, and the approximate location of the canopy pieces.

**Figure 1: Aerial view showing VH-ZRS accident details**
