Stall Warning/Low Speed Warning/AOA Systems to consider for Europa Classic Tri-gear N12AY

Description of type of warning, operation, and equipment.

Evaluation of stall strips on Euorpa N12AY

By Bud Yerly
Custom Flight Creations, Inc.
12/01/2010

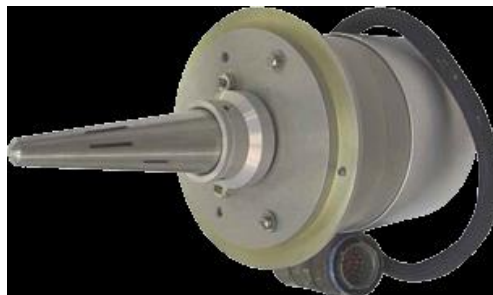
F-4 Phantom Type Probe

Heavy high speed probes are very accurate but not suitable for light aircraft.

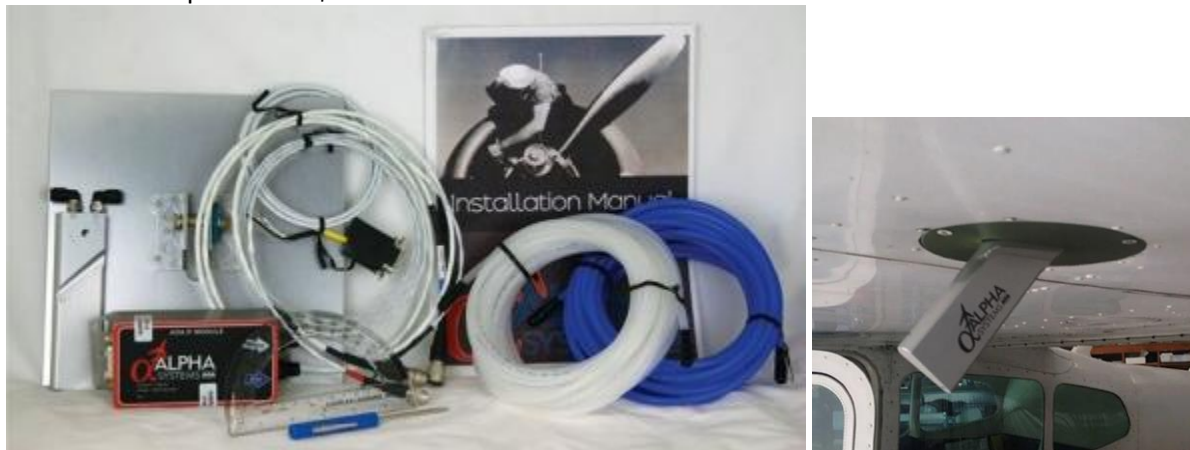
ALPHA SYSTEMS ANGLE OF ATTACK INDICATOR

This is a frequently used system on Piper type aircraft. Located well aft (about 60% chord) on the lower surface works quite well. \$2000+

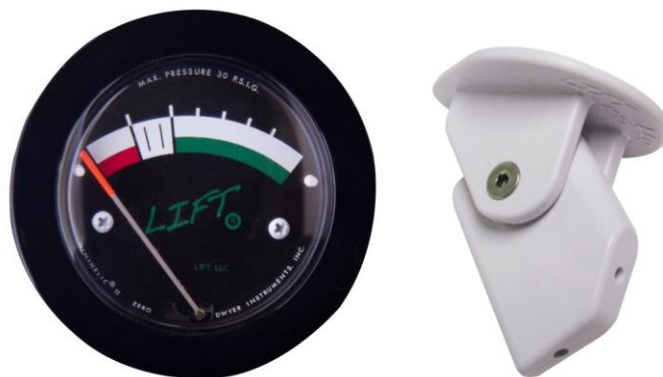
LIFT 2-1/4 AOA MONITOR SYSTEM FAA APPROVED.

A less expensive system and not as robustly built it works well as an add on warning system. Panel Mount or Glareshield Mount gauge and can cost typically \$389.00

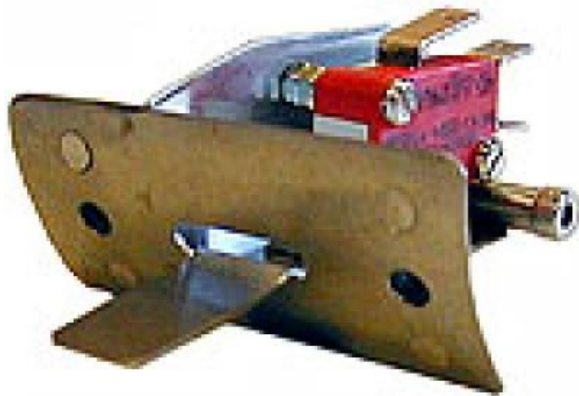
THE REDDISH STALL WARNER from \$89.95 to \$94.95

Many certified aircraft use a simple tab device located on the leading edge. At the warning angle of attack, the tab is lifted, closes a micro switch and a light/horn sounds in the cockpit. To install, normally it is riveted or screwed into the leading edge on the inside.

Rather large and clunky on a small wing. Hard to install without access from inside the wing.

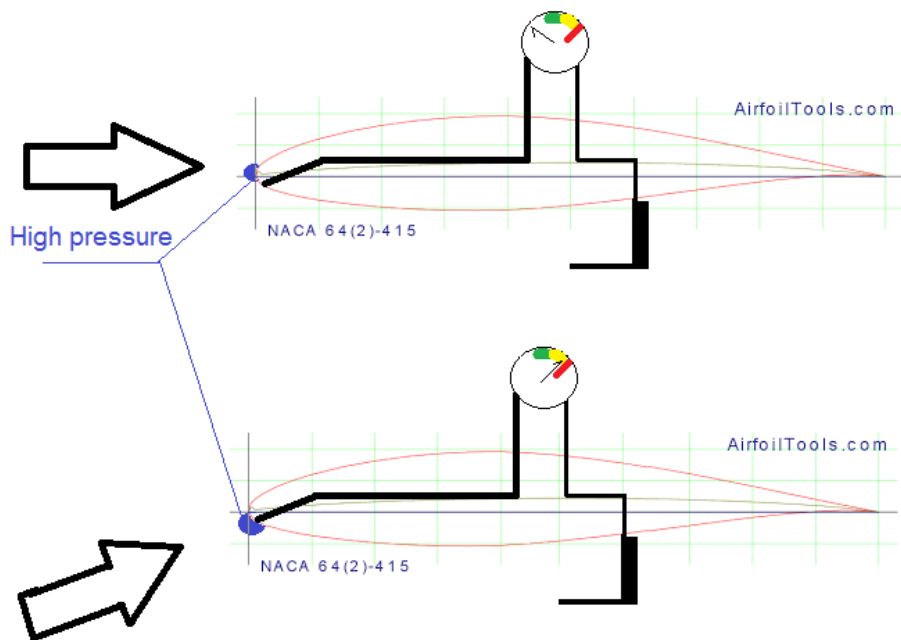
These pressure port systems for measuring pressure distribution around the airfoil and simple analogue pressure sensors have been around since the 1950's. Some use a pressure tap on the top and bottom of the wing and others near the leading and trailing edge. Below is my original stall warning using a differential between leading edge pressure and pitot pressure.

This works for flapped or clean as the pressure or stagnation point moves aft with flap extension, but the stagnation point pressure is still in the vicinity of the leading edge tube. When the pressure point is measured with a differential pressure device hooked to the static system or a point after the maximum thickness point it can be even more accurate as an AOA than using simple pitot reference pressure.

Some years ago I fabricated a simple probe and pitot pressure differential system. Unfortunately, it was very close to some patents and not producible for the masses or for my clients. I did make one for personal use and now find it has been less than ideal because it is a better stall warning device rather than a true AOA detector due to my stubborn use of analog sensors rather than digital. I used a simple differential pressure switch used in a furnace (HVAC) system of 0.5 to 3 inches H₂O. It combined leading edge pitot and cockpit static.

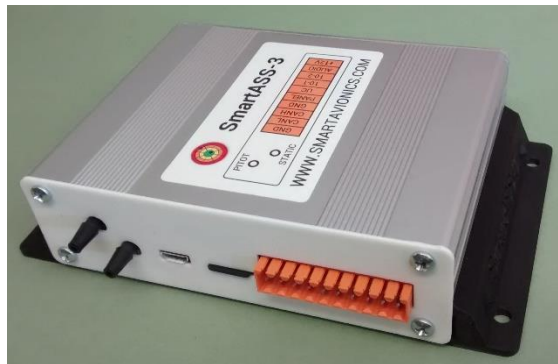
SmartASS-3 Air Speed Speaker 195 BP or about \$250USD

System is an airspeed sensor with accelerometers to assist in rate of speed change anticipation. This is a

very simple kit to install consisting of: SmartASS-3 device (includes micro SD card) Combined volume control and push switch + cable 1 metre 6mm OD tubing + 2 Tee connectors, Printed manual, USB Micro SD card reader, instrument panel label.

The SmartASS-3 is an Air Speed Speaker, or a talking Airspeed Indicator. This is excellent for the inattentive or rusty pilot. This system uses the auxiliary audio input of the radio/intercom system, the SmartASS-3 works from airspeeds between 25 and 250 Knots. The airspeed can be reported in Knots, MPH or KPH. It also provides a 'speed director' mode that informs the pilot when the airspeed deviates from a target airspeed (perfect for nailing that approach speed). *The SmartASS-3 is not a stall warning system and it does not provide a stall warning function.* A built-in accelerometer speed director mode takes into account wing loading due to gusts or a pilot pulling 'Gs'. It acts as a 'stall margin preserver' to help the pilot maintain a safe margin above stall the speed. Its uses are also handy for: Undercarriage down audible alert on approach if undercarriage is not down and locked. It also can provide audible alert triggered from external events such as a wind shift. Videos are available. This is a rather-easy system to install with many options only requiring panel/electrical work for power, intercom input, microswitches on the gear and flaps, etc.

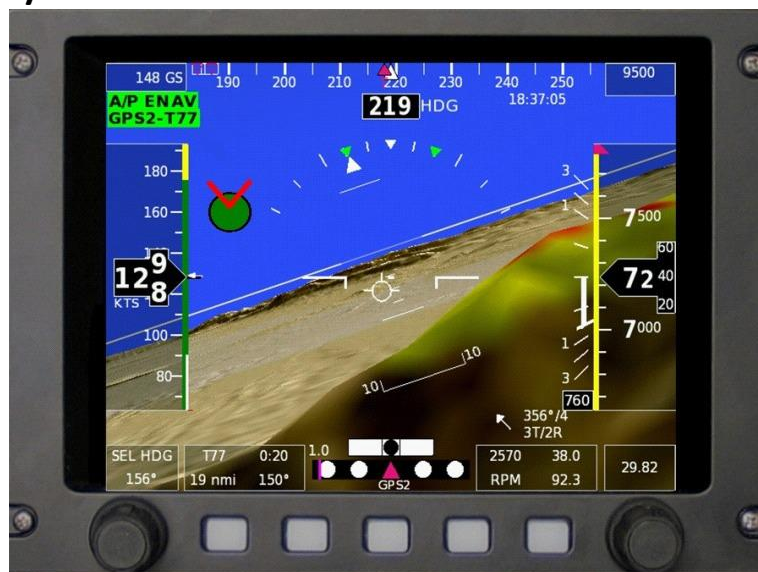
GRT Mini/HX

Displayed below is the Grand Rapids Mini which now comes with the software to display approach to stall or final approach speed:

No installation of special probes is required, as the angle of attack is computed from the AHRS airspeed, pitch attitude/rate, and vertical speed. *Note again that this method, although not requiring any sensors or additional pressure connections is not a true AOA.* Also, in my opinion it is not acceptable for soaring as its performance degrades in accuracy while in vertical rising or falling air such as thermal sailing. It is acceptable as a final approach slow speed warning even if flaps are lowered and for maneuvering in normal flight conditions. System is installed in the EFIS so there is no installation or additional equipment cost. Testing has proven it to be quite good as a reference during instrument approaches as well as for final turn and final control. I have not flow with this system hooked into the intercom or a buzzer for audible warning.

connection to the unit. The unit EFIS pitch, speed, rate accelerometers, and attitude sensors are used to approximate the approach angle (not AOA) from pitot/static, pitch and accelerometers and can provide visual display of the ideal final approach speed and warnings on the Primary Flight Display (PFD) for flying too fast or too slow. Some systems also have audible inputs for the intercom for an aural warning. *Again, like the Smart Ass and the probe type pressure sensors, this is not a true AoA or even aerodynamic stall warning.* The pilot can still enter into an accelerated stall through maneuvering, or from violent up or down drafts as in heavy convective weather. Talk to your EFIS manufacturer if this is right for you. In-flight setup of the approach aid on the Mini or HX is accomplished quite easily. Slow to a near stall and set the pitch bar and save settings. It is very effective for normal flight operations.
